TECHNICAL SERVICE BULLETIN

Triumph

HEATER AIR INTAKE APERATURE

TR7

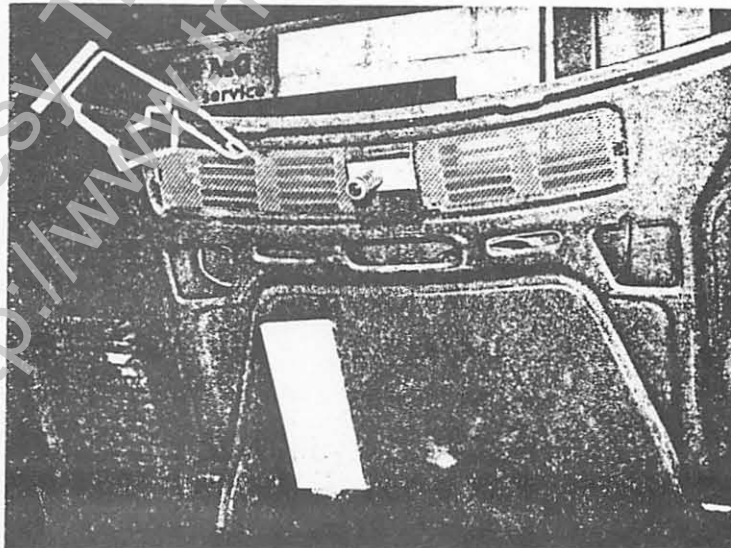
In areas where heavy snowfalls are not uncommon, the possibility exists where snow and ice can become impacted in the heater intake causing a restriction and therefore possible failure of the blower motor.

A screen is available, Part No. HAC-105, which can be installed to the underside of the hood intake aperature, (refer to diagram).
