# TECHNICAL SERVICE BULLETIN

76-F-1

FRONT SUSPENSION TURRET

TR7

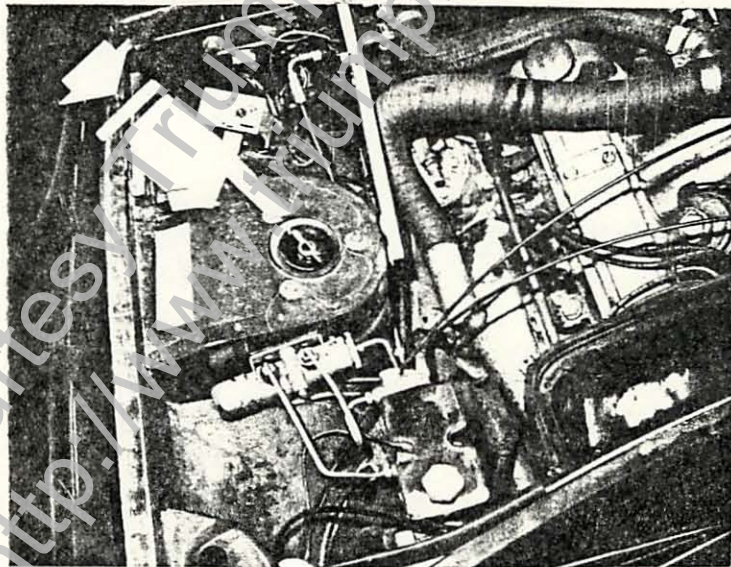
Water ingress at the upper mounting position of the front suspension turret can cause partial seizure of the upper bearing surface which results in heavy steering being experienced by the driver.

A simple solution to this problem is to pack the area shown in Fig. 1 with heavy grease. This operation should be carried out during pre-delivery.
