Recall Campaign Bulletin

RECALL CAMPAIGN A442
TR7 Accelerator Cable

1975 & 1976
TR7'S

December, 1977

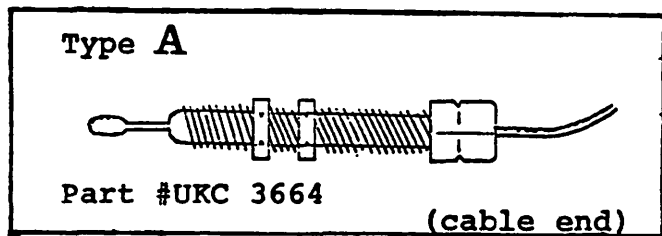
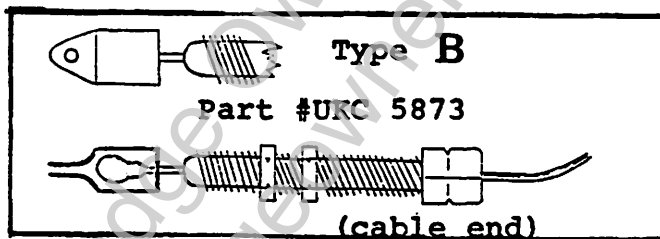
ACL 1 to ACL 21667 - A
ACL 21668 to ACL 23620 - B

ACL 1 to ACL 20409 - A
ACL 20410 to ACL 23620 - B

2. Type A cable/vehicle - remove cable from throttle link.
Type B cable/vehicle - remove clevis pin from link at carb end.
3. Remove lock nut from adjusting thread of outer cable and remove cable from cable anchor bracket.

9. Type A cable/vehicle - hook cable link to carb linkage.
Type B cable/vehicle - place clevis pin in link and replace lock pin.
10. Adjust cable to correct length and secure lock nut.
