TECHNICAL SERVICE BULLETIN

ITEM T81/13

SUBJECT: CYLINDER HEAD TORQUE P.D.I.

MODELS: TR7

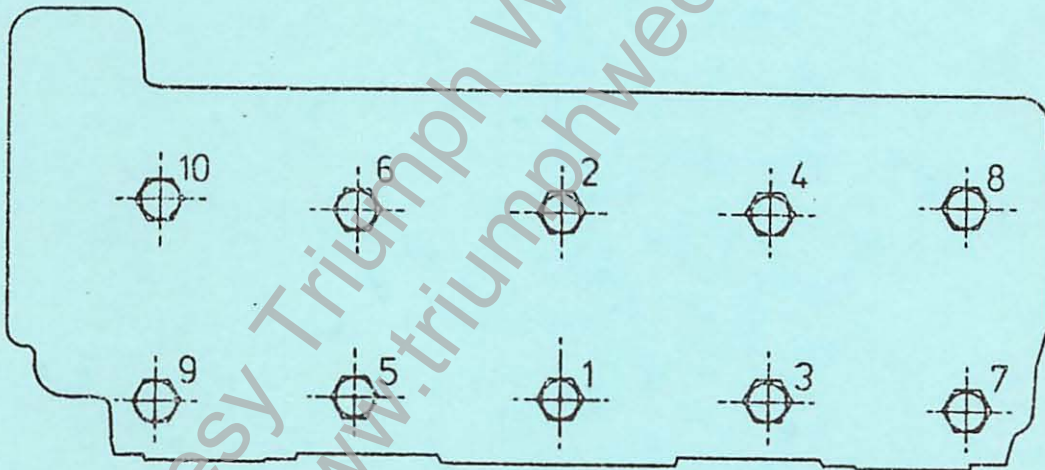
Upon receipt of this bulletin all dealer technicians should be made aware of the fact that before any P.D.I. work is started the cylinder head nuts and bolts must be torqued to 50 lb/ft with the engine COLD.

When checking the torque loading of nuts and bolts, they should first be slackened off to overcome static friction and retightened to the correct loading in the sequence illustrated.

When this has been done, a spot of paint should be applied to a head nut as a reminder that torquing is not necessary at the 1,000 mile service.
