## TECHNICAL SERVICE BULLETIN

HEADLAMP PAINT ADHESION

TR7

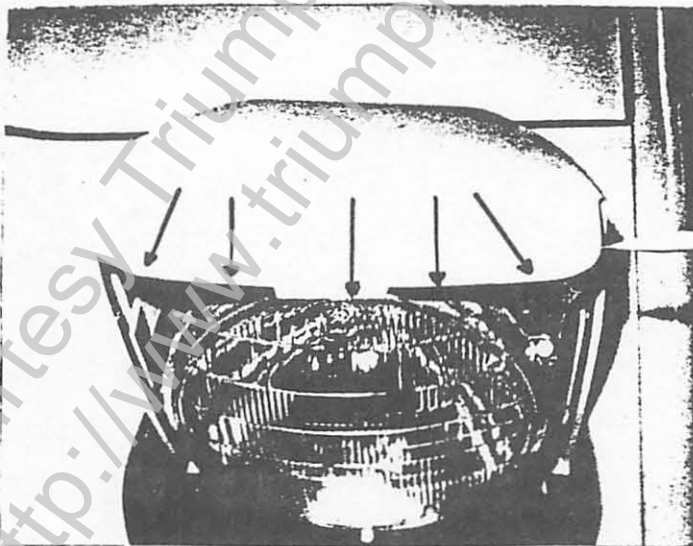
Difficulty has been experienced on early TR7's with the paint flaking along the leading edge of the headlamp assembly (Refer to Diagram).

It is recommended when refinishing this area, to add a radius to leading edge of lamp assembly prior to painting. Please note a time of 1/2 hour per headlamp assembly will be allowed for carrying out this operation.
